TECHNICAL REPORT
STORMWATER MANAGEMENT MAINTENANCE PLAN

WHITTIER FIELD
BLOCK 405, LOTS 1,7,8 & 11
CITY OF CAMDEN
CAMDEN COUNTY, NEW JERSEY

STORMWATER MANAGEMENT MEASURES

MAINTENANCE PLAN

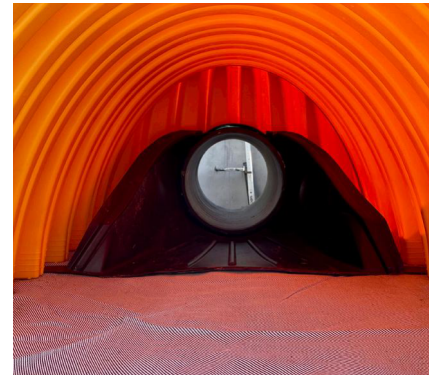
Looking down the Isolator Row Plus from the manhole opening, ADS Plus Fabric is shown between the chamber and stone base.

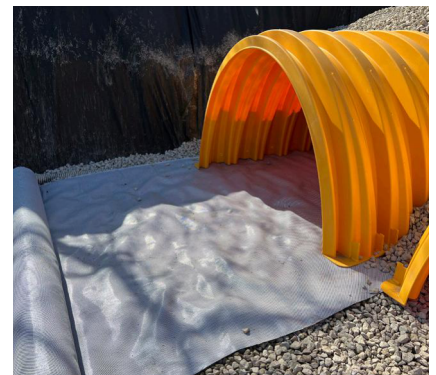
StormTech Isolator Row Plus with Overflow Structure (not to scale)
